# **General Aviation Airworthiness Alerts**

**AC No. 43-16**

**ALERT NO. 234  
JANUARY 1998**

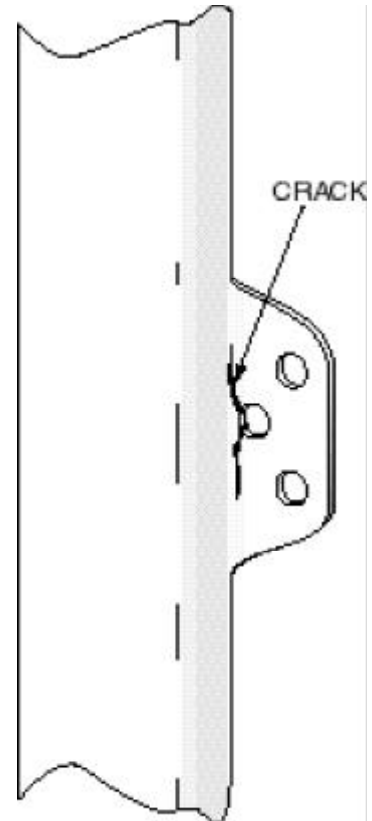
<b>Cessna</b>	<b>Doorpost Defect</b>
<b>Model 172N</b>	<b>5311</b>
<b>Skyhawk</b>

During a scheduled inspection, the left forward cabin-entry doorpost was found cracked.

The crack was approximately 1.125-inches long and was located on the aft side of the forward doorpost bulkhead (P/N 0513282-3) adjacent to the lower door hinge. The crack ran through one of the door hinge fastener holes. (Refer to

the following illustration.) It was speculated that excessive stress from the entry door may have caused this defect. The FAA Service Difficulty Reporting program data base also contains 12 other similar entries.

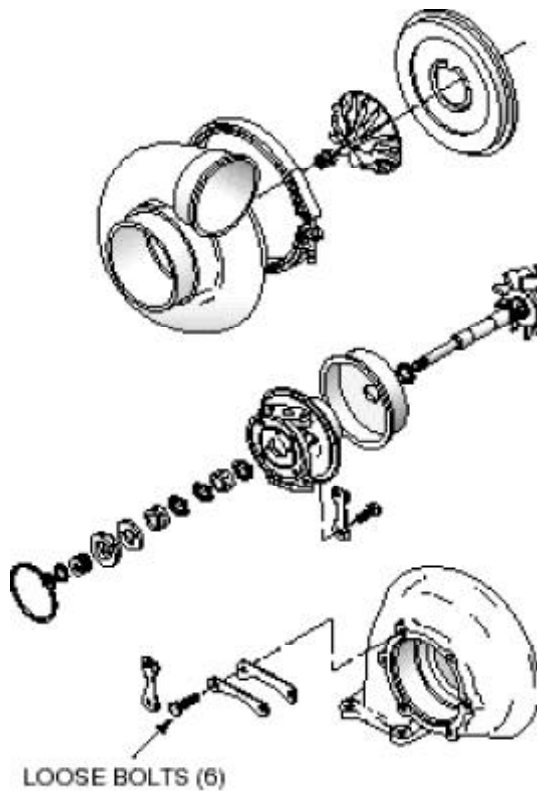
**Defective  
Turbocharger  
Assembly  
8120**

During an annual inspection, the turbocharger center section was found to be loose where it attaches to the hot side.

All six of the attachment bolts were loose (it appeared they had not been tightened during the previous assembly), and two of the bolt-locking tabs had not been set. (Refer to the following illustration.) Exhaust stains indicated the unit had been leaking at this junction. The submitter stated that all bolts and nuts should be checked for torque before safetying and/or setting the locking tabs. It would seem this defect was the result of someone not giving full attention to the task at hand.

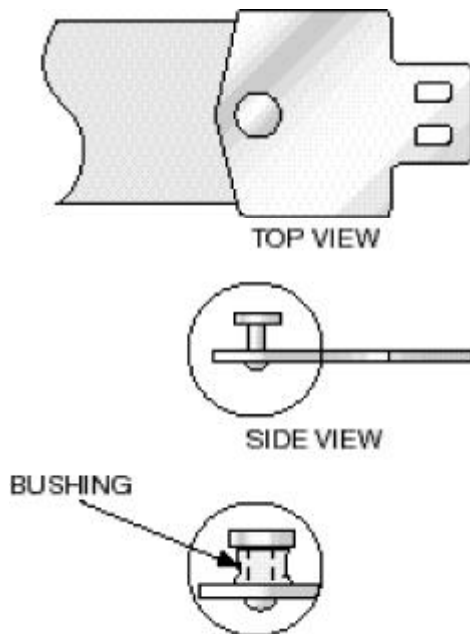
<b>Piper Model PA 28RT-201T Turbo Arrow</b>	<b>Defective Seat Restraints 2560</b>
---	---

During a scheduled inspection, both of the pilot seat-restraint systems were found defective.

The nylon shoulder harness retaining bushing (P/N FD5667-3) was found to be missing from both pilot’s seat lapbelts. (Refer to the following illustration.) The restraint system was manufactured by Davis Aircraft Products, Inc., and their representative stated there are no authorized field repairs for this condition. The representative stated Davis Aircraft Products, Inc. will replace the defective parts at no charge. This condition may exist on various other aircraft, and should be corrected when found. “Tie wraps” should not be used as a replacement for the nylon bushing!

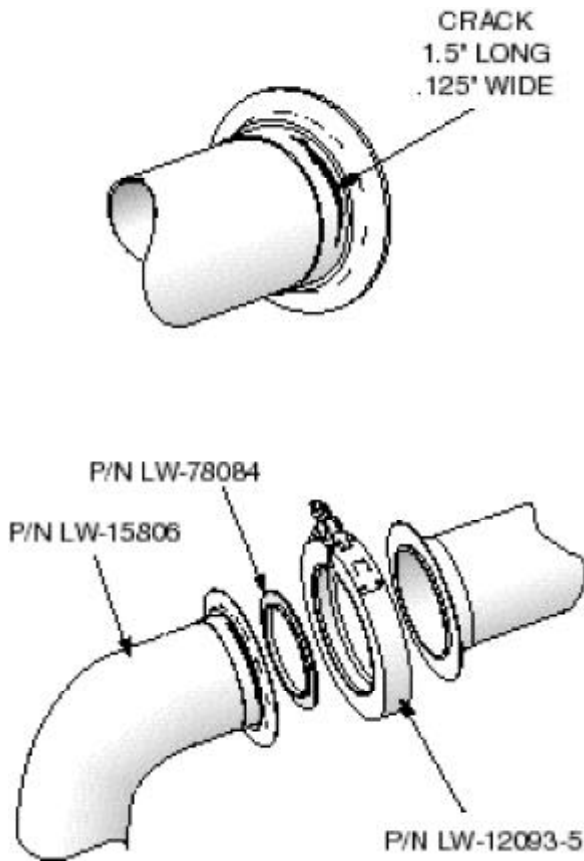
**Engine Exhaust**  
**System Cracks**  
**7800**

During a routine engine exhaust system inspection, the upper-right engine cowling louvers were found stained.

When the cowling was removed, a heavy exhaust stain was found. It appeared the exhaust leak originated at the upper-right intermediate exhaust pipe flange clamp. In an attempt to “seat” the gasket, the clamp was loosened and rotated; however, this procedure failed to stop the exhaust leak, and the clamp was removed. A crack, which was approximately 1.5-inches long and .125-inch wide, was found at the intermediate exhaust pipe (P/N LW15806) flange base. (Refer to the following illustration.) The exhaust pipe was removed, the flange area was cleaned, and numerous stress cracks were revealed around the circumference. The submitter speculated these cracks may have been caused by vibration, extreme temperature differentials, or thermal shock. The submitter suggested that a complete “soap-pressure check” be accomplished on the exhaust system every

25 operating hours, and that the system be disassembled for a "visual check" during every annual inspection.

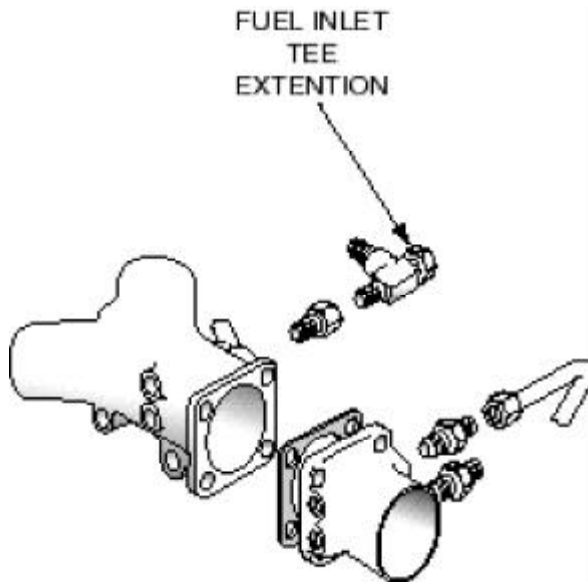
<b>Piper</b>	<b>Engine Failure</b>
<b>Model PA 34-220T</b>	<b>7320</b>
<b>Seneca III</b>

The left engine failed during flight, and the pilot observed fuel coming from the engine cowl. A safe single-engine landing was made.

While investigating the cause of this incident, it was found that an "extension" fitting on the fuel injection assembly had broken. (Refer to the following illustration.) The fitting (P/N 630119) failed at the threads used to attach it to the throttle control. The available evidence indicated the fitting had suffered previous damage from "removal attempts." The submitter stated it is common for maintenance personnel to mistakenly believe that this fitting conceals a fuel screen which

requires inspection. It was speculated the fitting had been damaged during repeated removals and installations.
